A framework for developing
mine-site completion
criteria in Western Australia

Case Studies

5 Case Studies

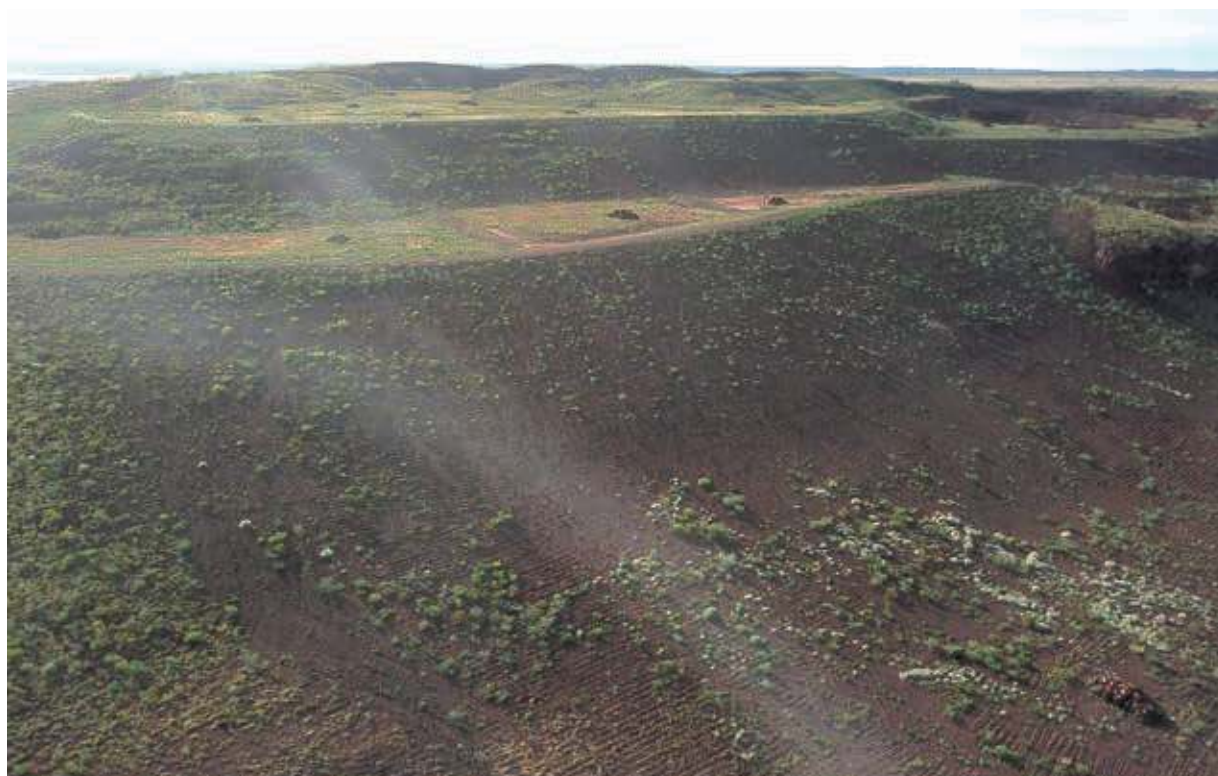
FIGURE 5.3 Cattle Gorge before (top image) and after (bottom image) rehabilitation

Mining at Shay Gap and Sunrise Hill was approved in 1972 and at Nimingarra in 1986. BHP acquired full ownership of the mines from Mount Goldsworthy Mining in 1991 and developed the Yarrie, Cattle Gorge and Cundaline mines between 1992 and 2009. BHP commenced progressive rehabilitation in 1995. In 2014, mining operations were suspended and a stewardship program of 'no regrets' demolition and rehabilitation is currently underway. In 2016 Cattle Gorge was rehabilitated as part of this stewardship program and is the most recent example of rehabilitation at the GNA Operation (Figure 5.3).

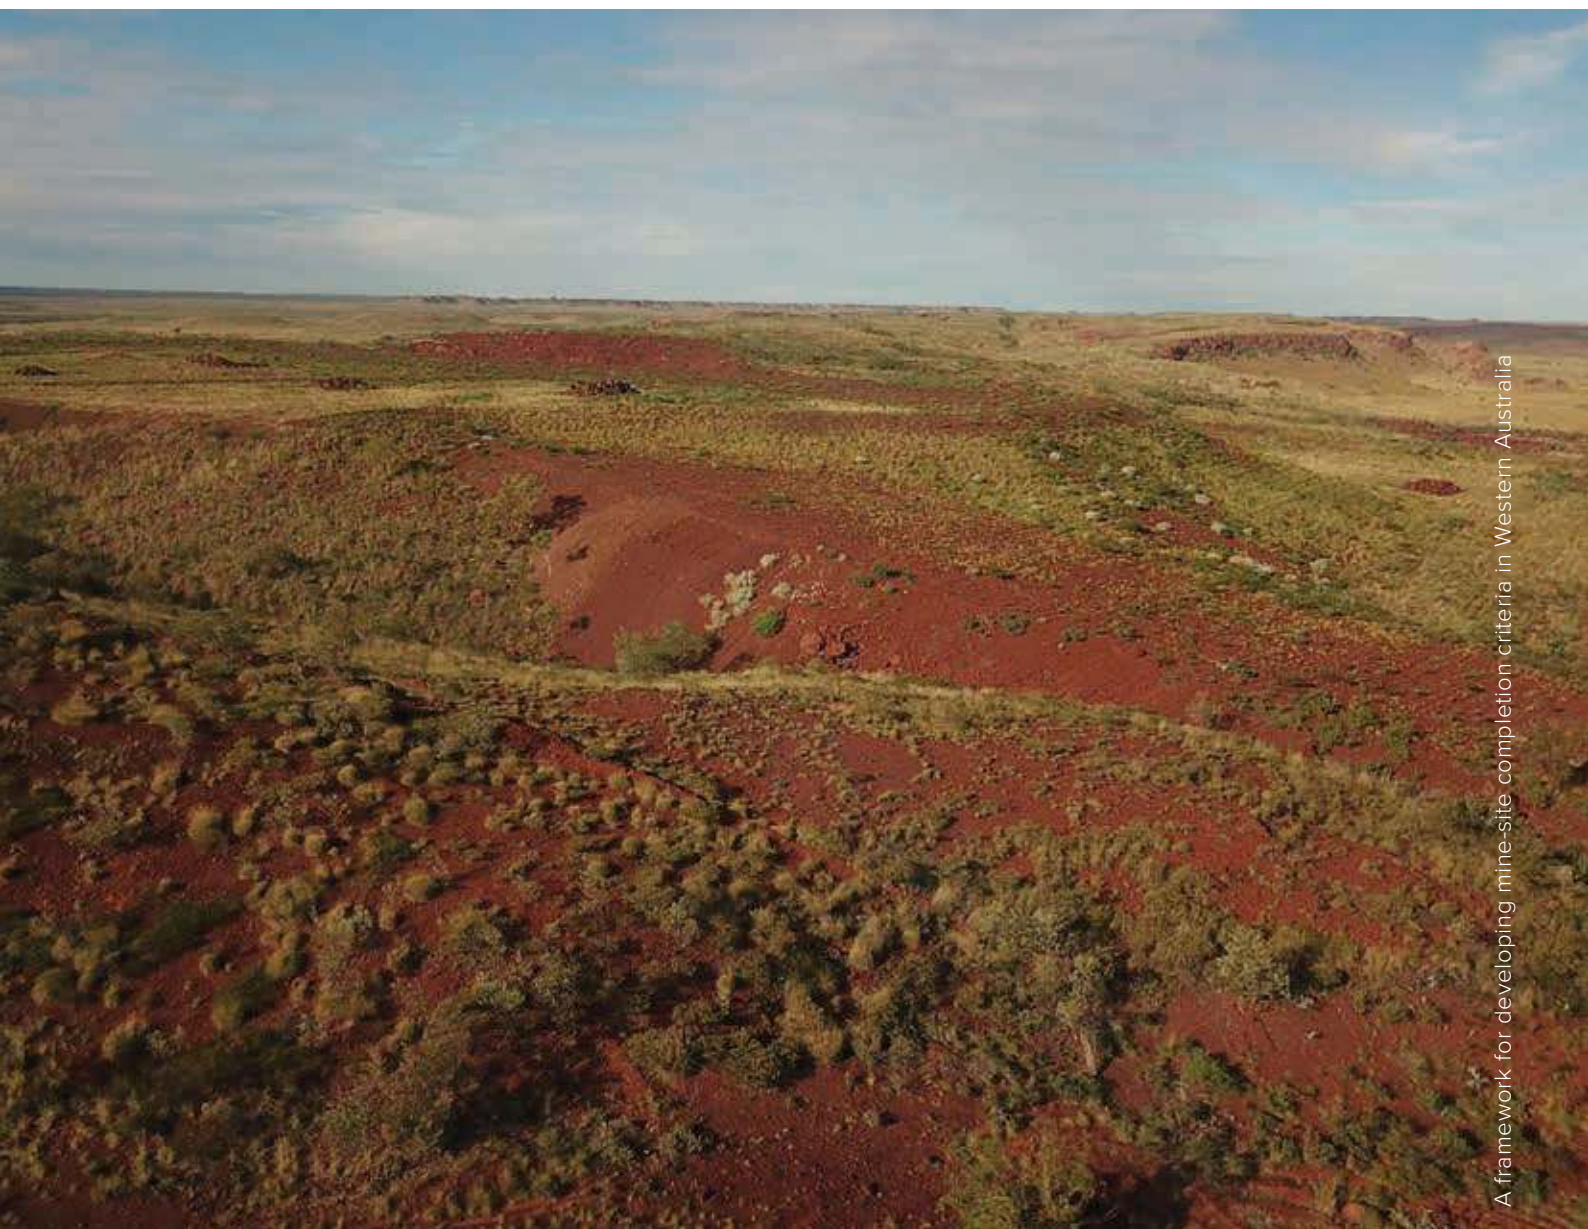
FIGURE 5.6 Cattle Gorge constructed landform (foreground), natural landform (background)

At GNA, BHP's landform design principles, which include preserving ridgelines and softening sharp edges, have achieved landforms that blend with natural landforms (Figure 5.6).

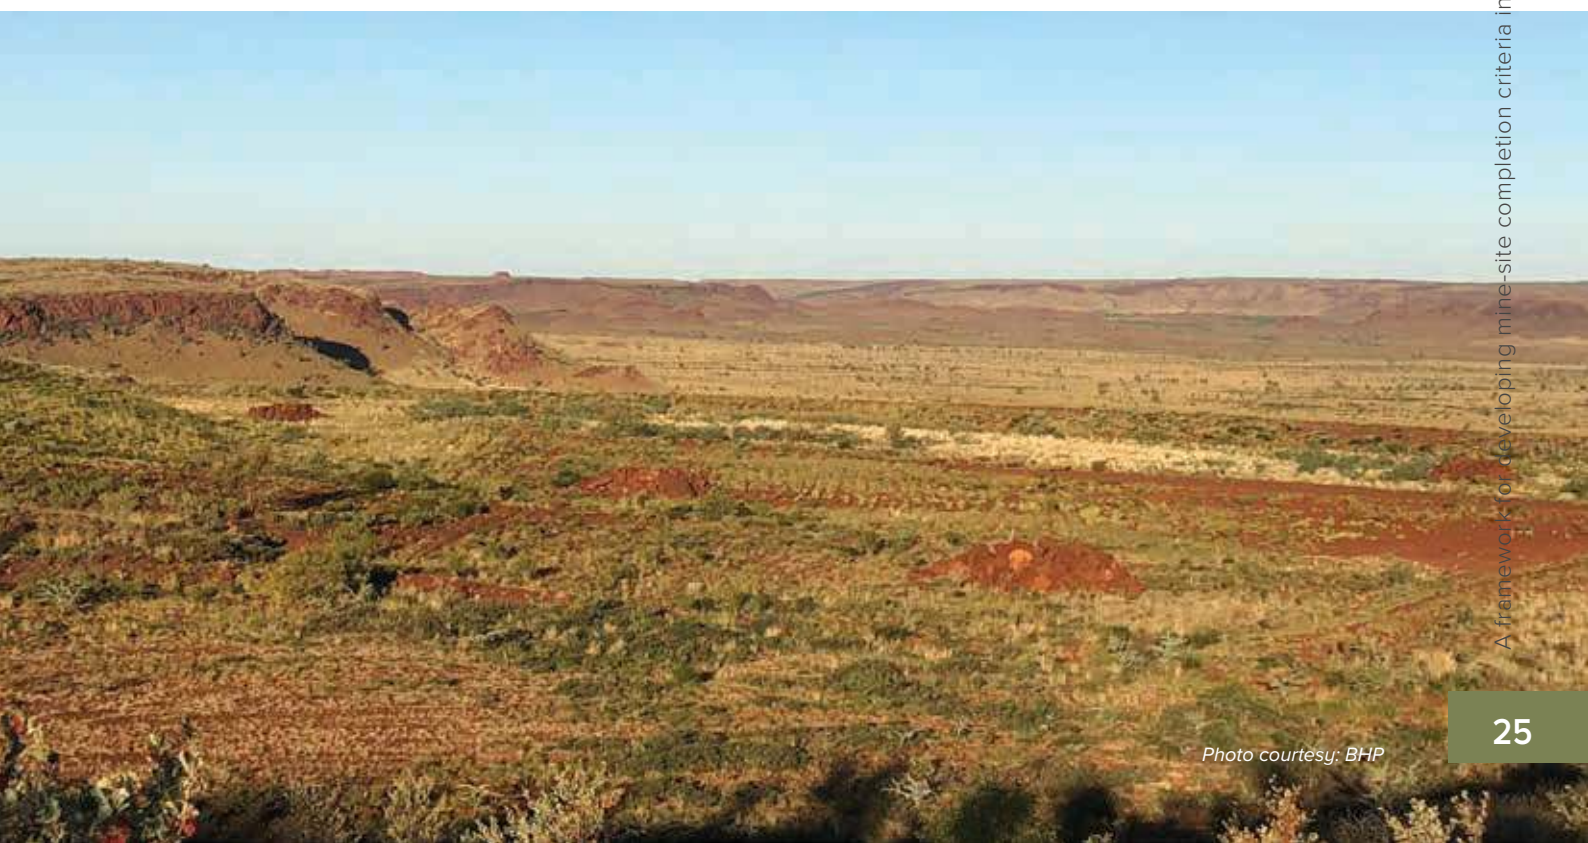
FIGURE 5.7 Seed provenance map for Western Australian Iron Ore mine sites

Development of a seed provenance map in consultation with the Department of Parks and Wildlife (now Department of Biodiversity Conservation and Attractions) (Source: BHP Billiton (2013) Figure 5.7) enabled the provenance criterion to be included in BHP's criteria framework and provided a basis for auditing conformance with the criterion.

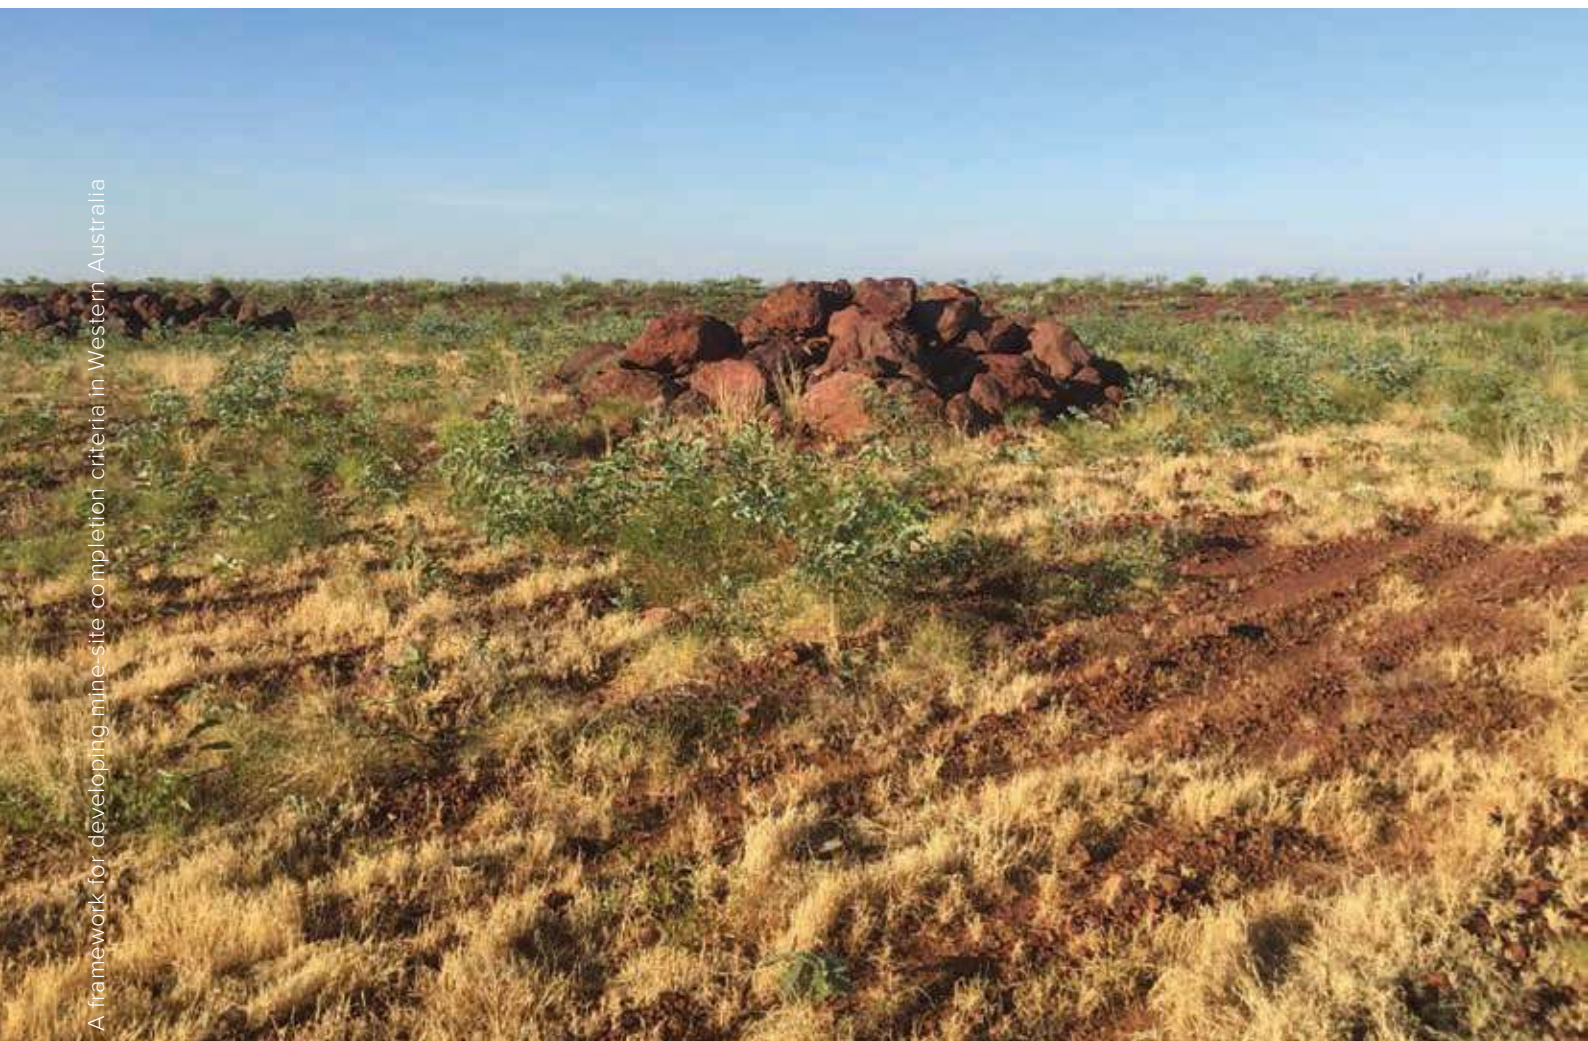
FIGURE 5.8 Example of a rock pile at Goldsworthy Northern Areas

At Cattle Gorge, both rock piles (Figure 5.8) and bat habitat (Figure 5.9) were incorporated into rehabilitation. Three different species of bats were acoustically recorded in the bat habitat structure three days after practical completion.

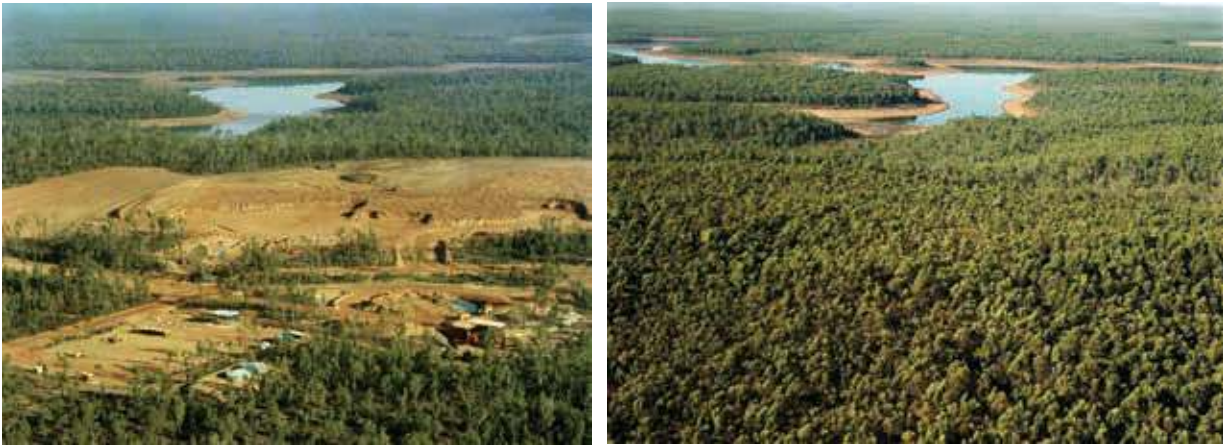
FIGURE 5.13 Mining at Alcoa's Huntly operation in 1980 (left) and after restoration in 2001 (right)

Mine pits are rehabilitated. The first step consists of reshaping or landscaping the mine pit by battering down the pit faces to blend with the surrounding topography, along with deep ripping of compacted areas to 1.5m depth to facilitate percolation and root exploration. Overburden and topsoil materials are returned in sequence and, finally, a second shallow (0.8m) ripping along the contour assists in reducing erosion, promoting rainfall infiltration and preparing a seedbed for applied seed. Because topsoil contains a seedbank important for plant establishment, and is enriched in organic matter, nutrients and microorganisms, it is immediately transferred from stripping areas to rehabilitate nearby pits whenever possible. Logs and rocks are also returned to provide habitat for native fauna. Seed of more than 60 species is collected from the forest ensuring local provenance and applied within a week of contour ripping to supplement plant species established from the soil seedbank. All soil return, contour ripping and seeding is carried out during the drier summer months. Plant species that are difficult to return via topsoil or collected seed are propagated under nursery conditions and seedlings are planted during the winter months. A one-off application of fertiliser by helicopter occurs in the second spring after establishment, to replace soil nutrients lost in the clearing and mining steps and to encourage early plant growth.

Rehabilitation is a progressive operation, with approximately 600 a of forest cleared for mining and subsequently rehabilitated each year. Approximately 20,000ha of rehabilitation has been established since the first rehabilitation was completed in 1966. An example of Alcoa's rehabilitation is illustrated in (Source: Grant and Gardner (2005)) Figure 5.13. The images depict an area of the jarrah forest where, after bauxite mining, all rehabilitation objectives were met.
